CAPISIC BROOK WATERSHED

FLOOD PLAIN MANAGEMENT STUDY

Technical Report Summary

OCTOBER 1995

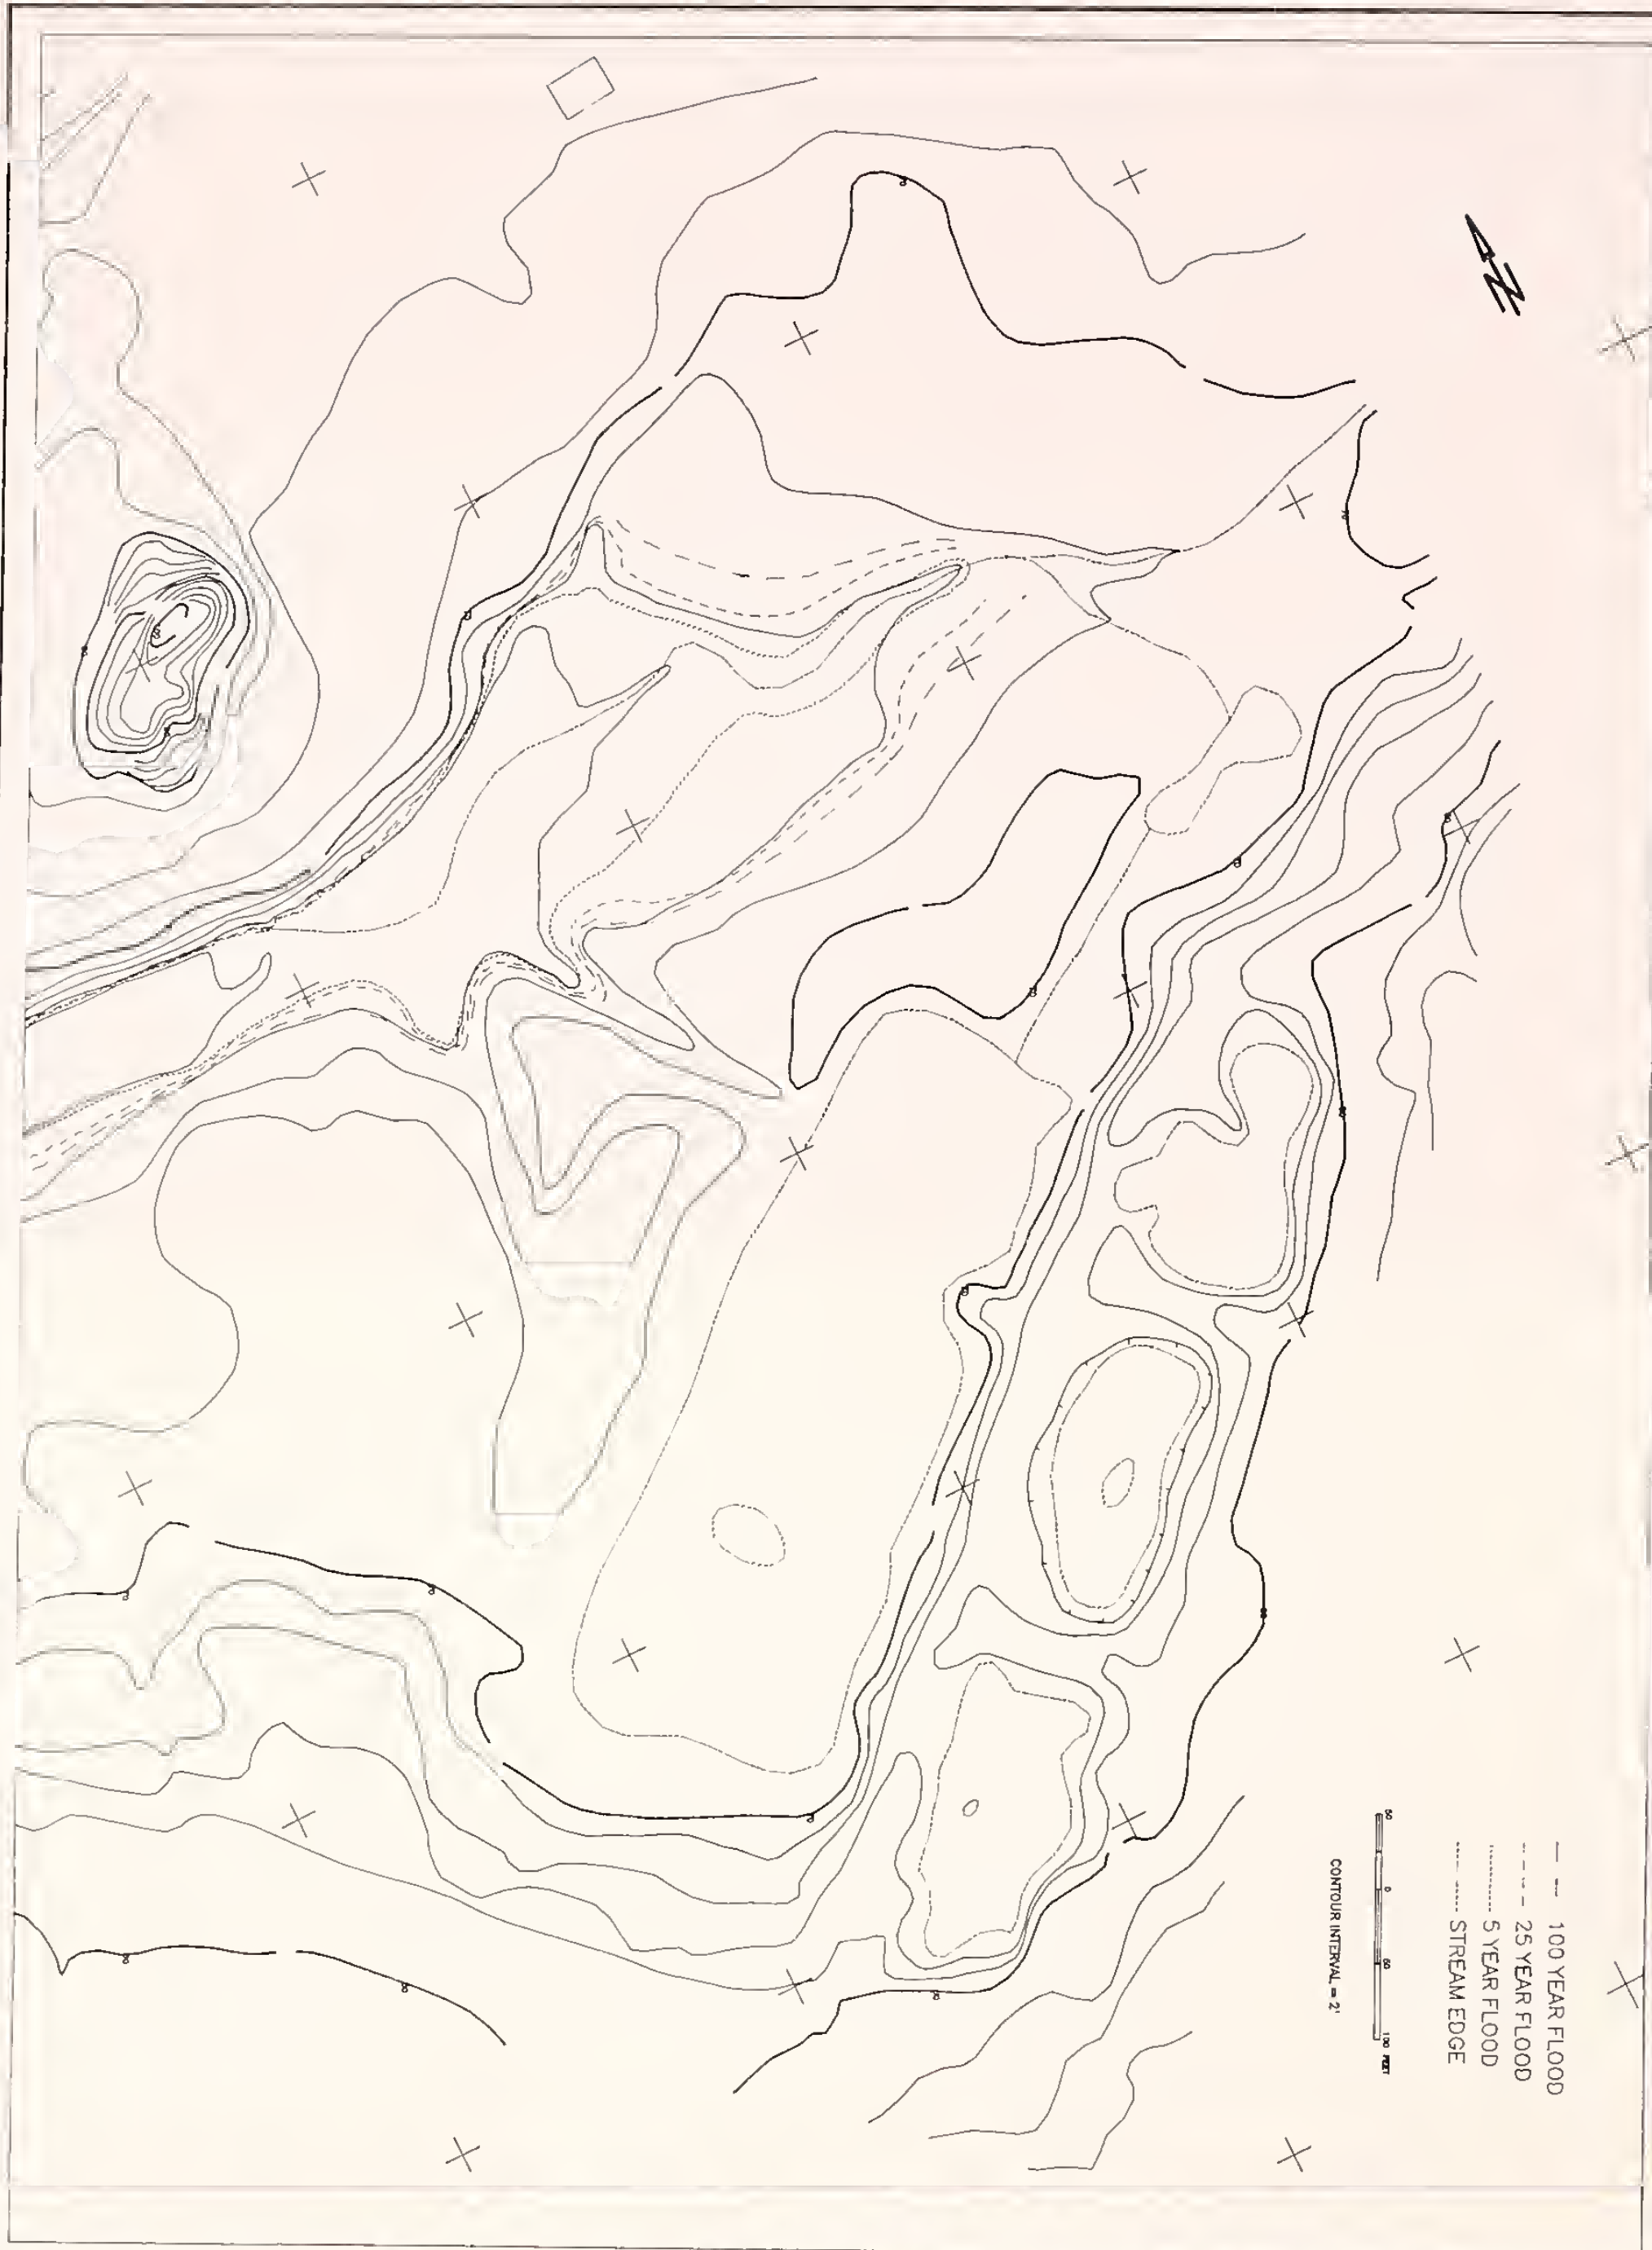
100 YEAR FLOOD
25 YEAR FLOOD
5 YEAR FLOOD
STREAM EDGE

CONTOUR INTERVAL = 2'
